First Citizens Bank Building Facade Renovations

Client:
1st Security Bank
Corporation

Location:
Billings, MT

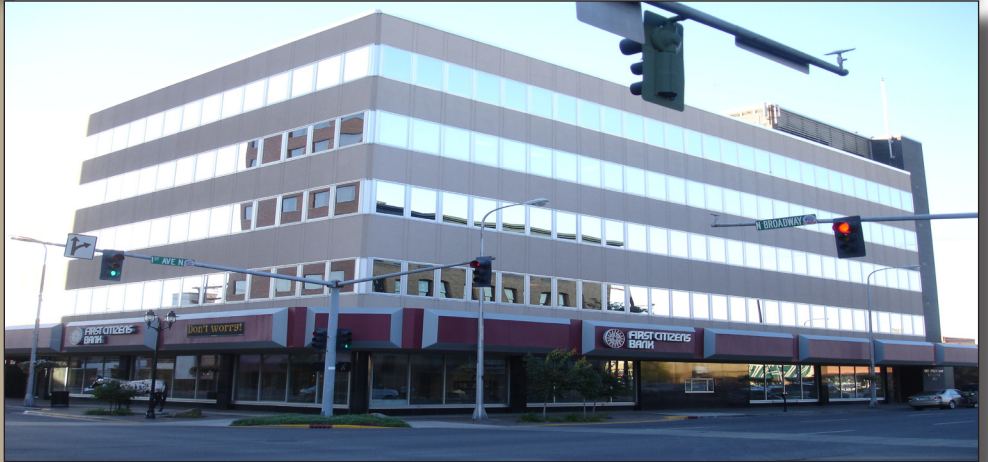
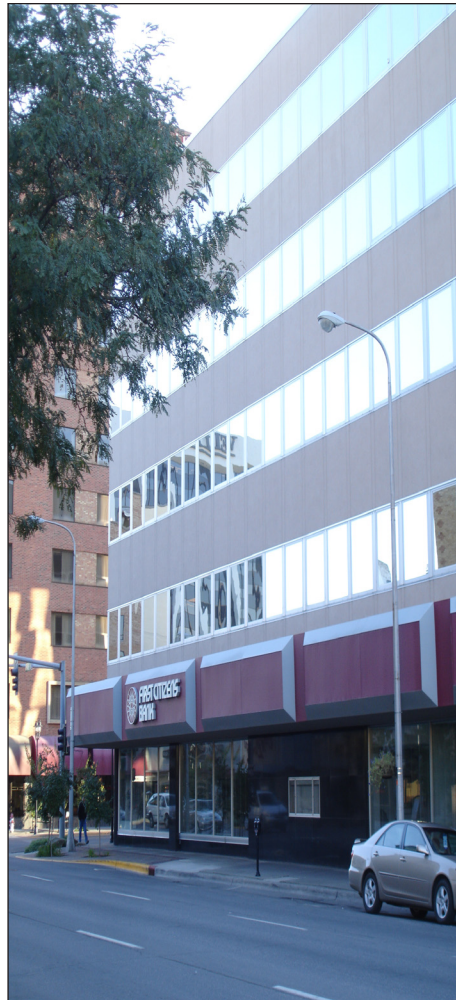
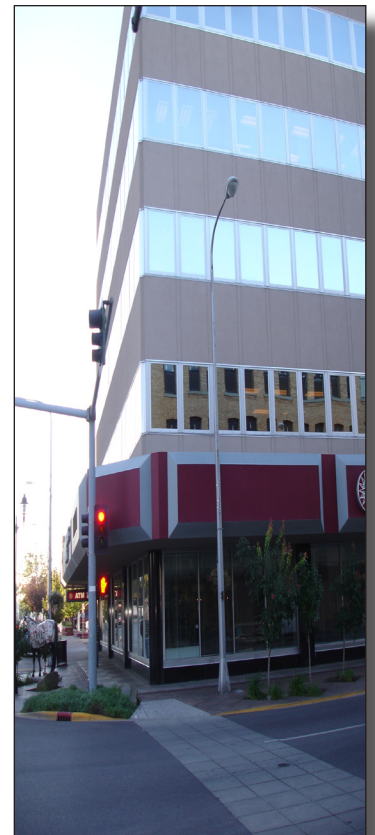
Our solution is what you see today. The culprit was the original curtain wall system and how it was designed and flashed. By removing the newly installed windows, redesigning the window flashing and adding a new EIFS exterior, which also improved the energy efficiency of the building, we solved the puzzle. By thinking outside the box our design solution has a payback that the building owners are still enjoying.

Two years prior to our involvement, the bank invested in new windows for the entire exterior of the building, thinking this would solve their water infiltration problems. When they discovered that the new windows did not solve the problem or even improve the situation we were called in to investigate the building envelope, determine the cause of the problem and design a solution.
